CASE NO. 6:20-bk-10583-SC

**Complaint To Determine
Dischargeability Of Debt Pursuant To
11 USC § 523(a)(2)(A))**

PROJECT: MURRAY'S RESIDENCE FRAMING REPAIRS
ADDRESS: 28728 PALISADES DR., LAKE ARROWHEAD, CA 92352
OWNER: VERNON MURRAY
ADDRESS: 215 N. MARENGO, PASADENA, CA 91101
PREPARED BY: ALEC SEAMAN CONSTRUCTION
ADDRESS: P.O. BOX 3070 BIG BEAR LAKE, CA 92315

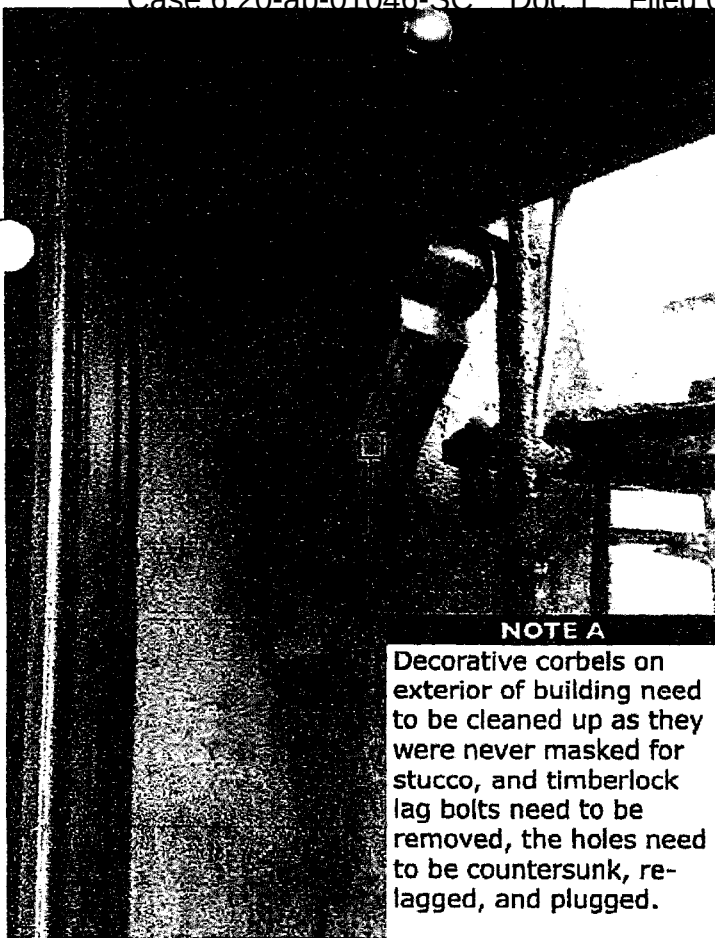
NOTE A

Decorative corbels on exterior of building need to be cleaned up as they were never masked for stucco, and timberlock lag bolts need to be removed, the holes need to be countersunk, re-lagged, and plugged.

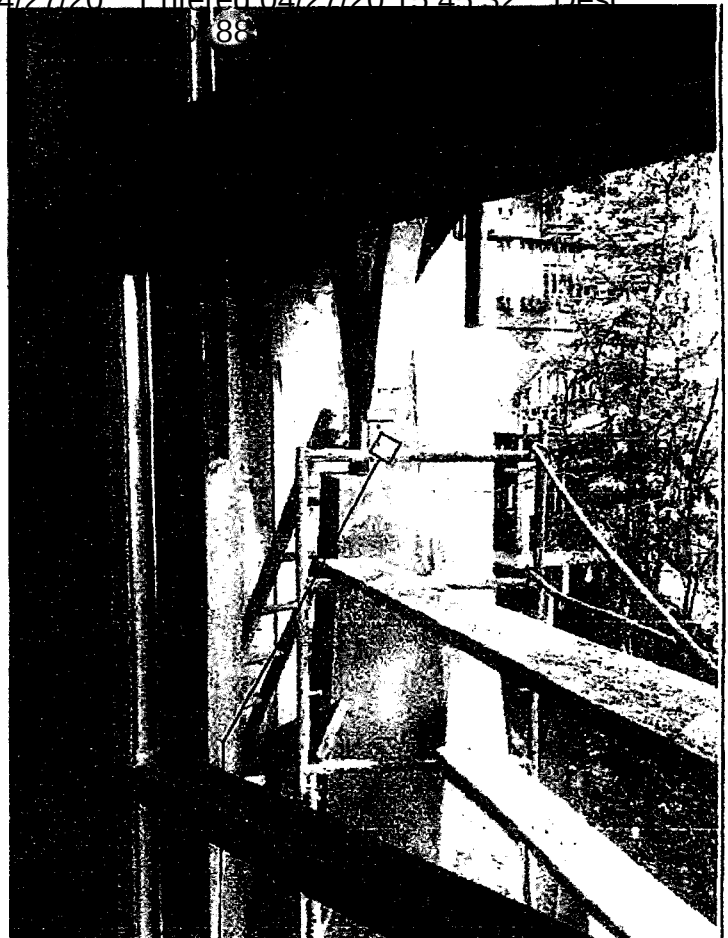
NOTE B

Mechanical fasteners at post to girder connection missing. Install ornamental "T" straps.

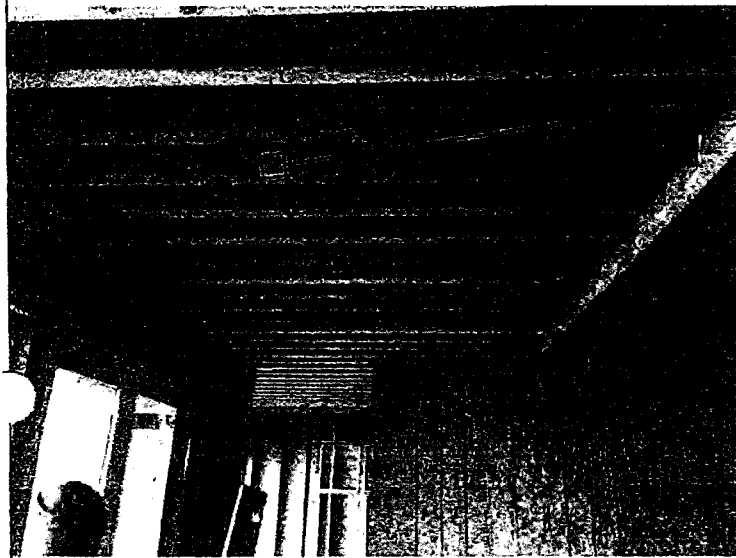
NOTE B

Where joists are sloped for upper deck water run-off, joists need to be furred down for future soffit detail.

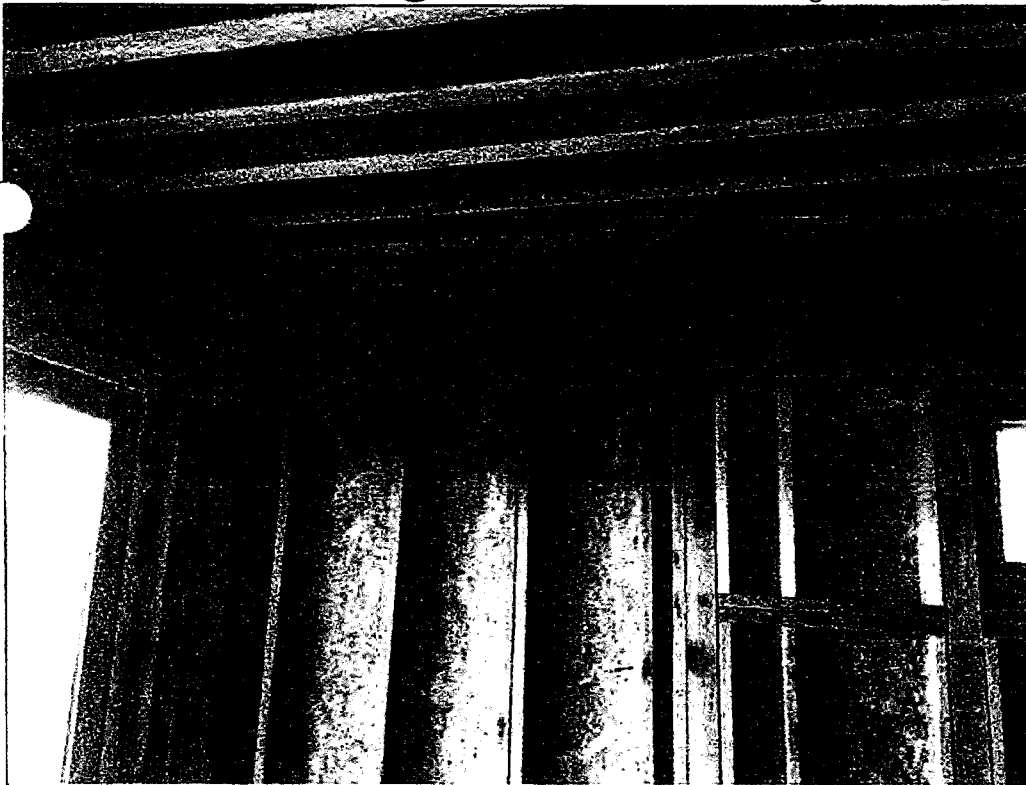
NOTE A

- Blocks missing where shear transfers, walls already stuccoed. Recommendation: Insulate, make sure that all electrical is in place and then add interior shear panels.

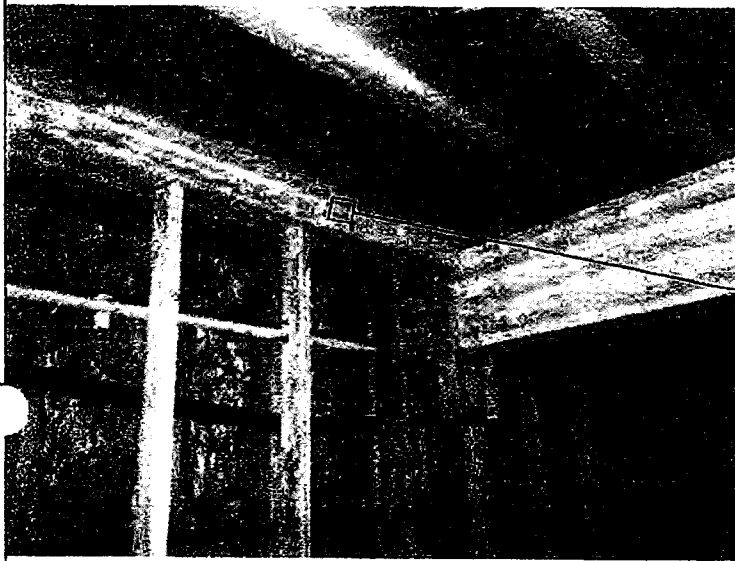
NOTE B

- Remove unnecessary board along top of wall

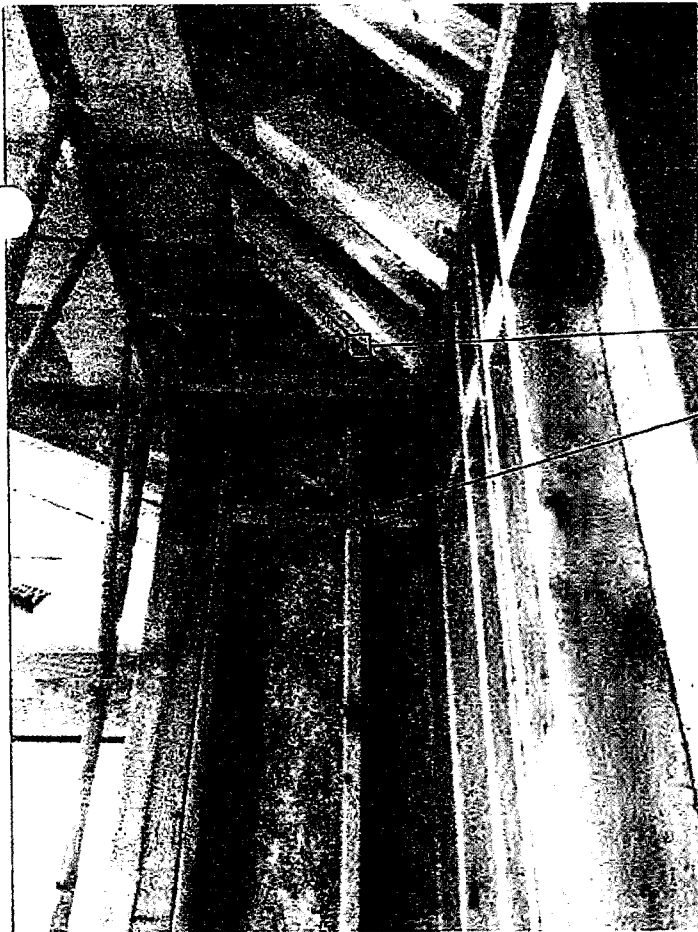
NOTE A

• Substandard framing, not to the highest building standards. Framing should have been cut tight, and where shear transfers, solid 3x or 4x members should have been installed.

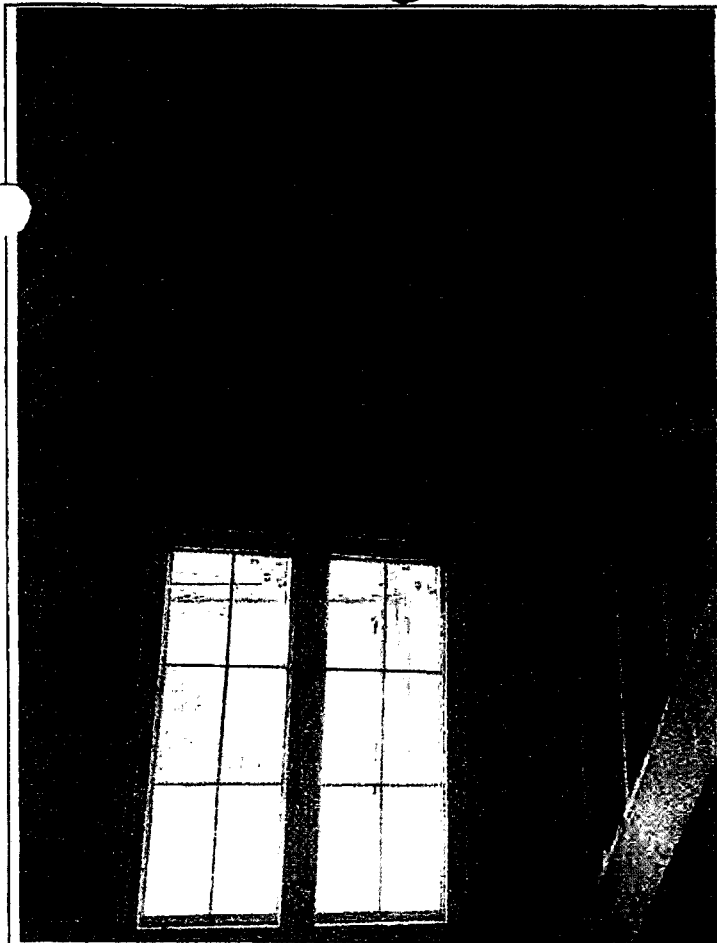
NOTE A

- Backing blocks missing on balloon framed walls

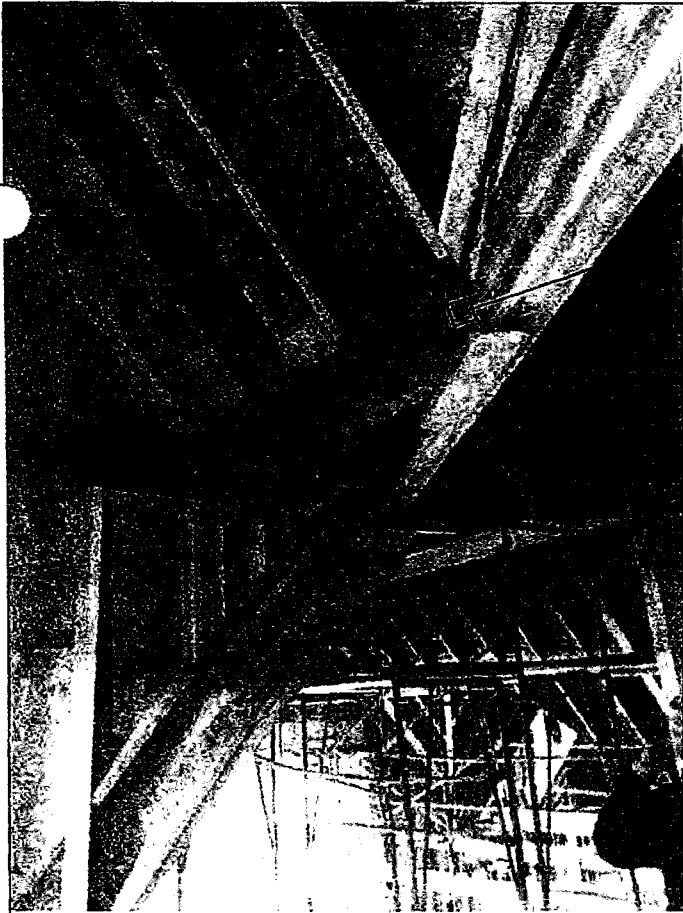
NOTE A

• Missing mechanical connection here. Recommend Simpson LS70 or engineer's recommendation

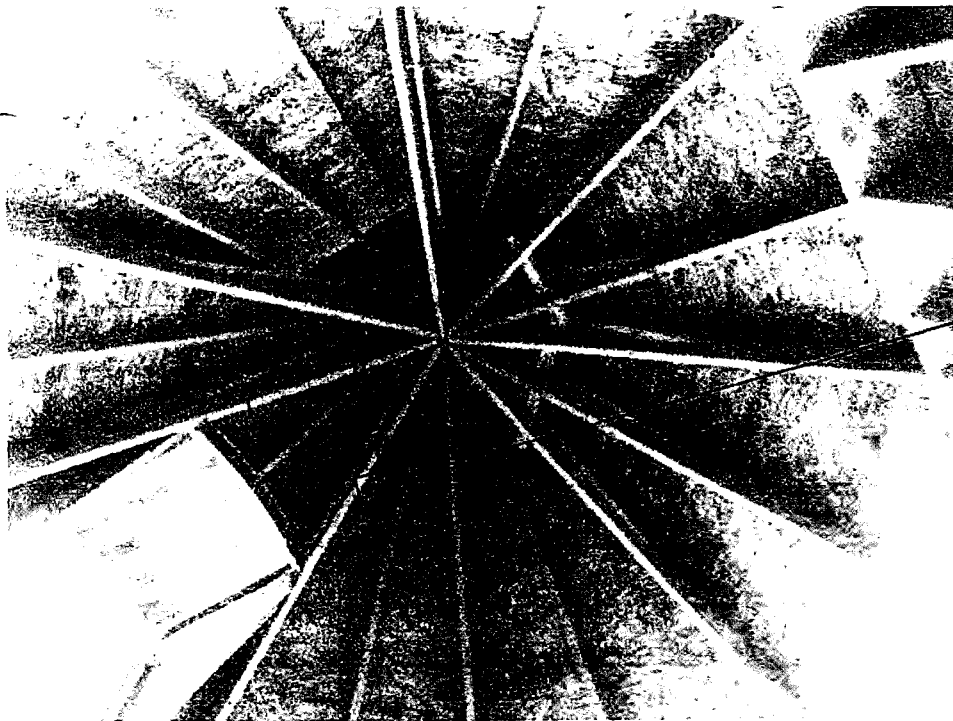
NOTE A

• Turret before framing corrections added.
